Cumbria Floods Technical Report

Factual report on meteorology, hydrology and impacts of January 2005 flooding in Cumbria

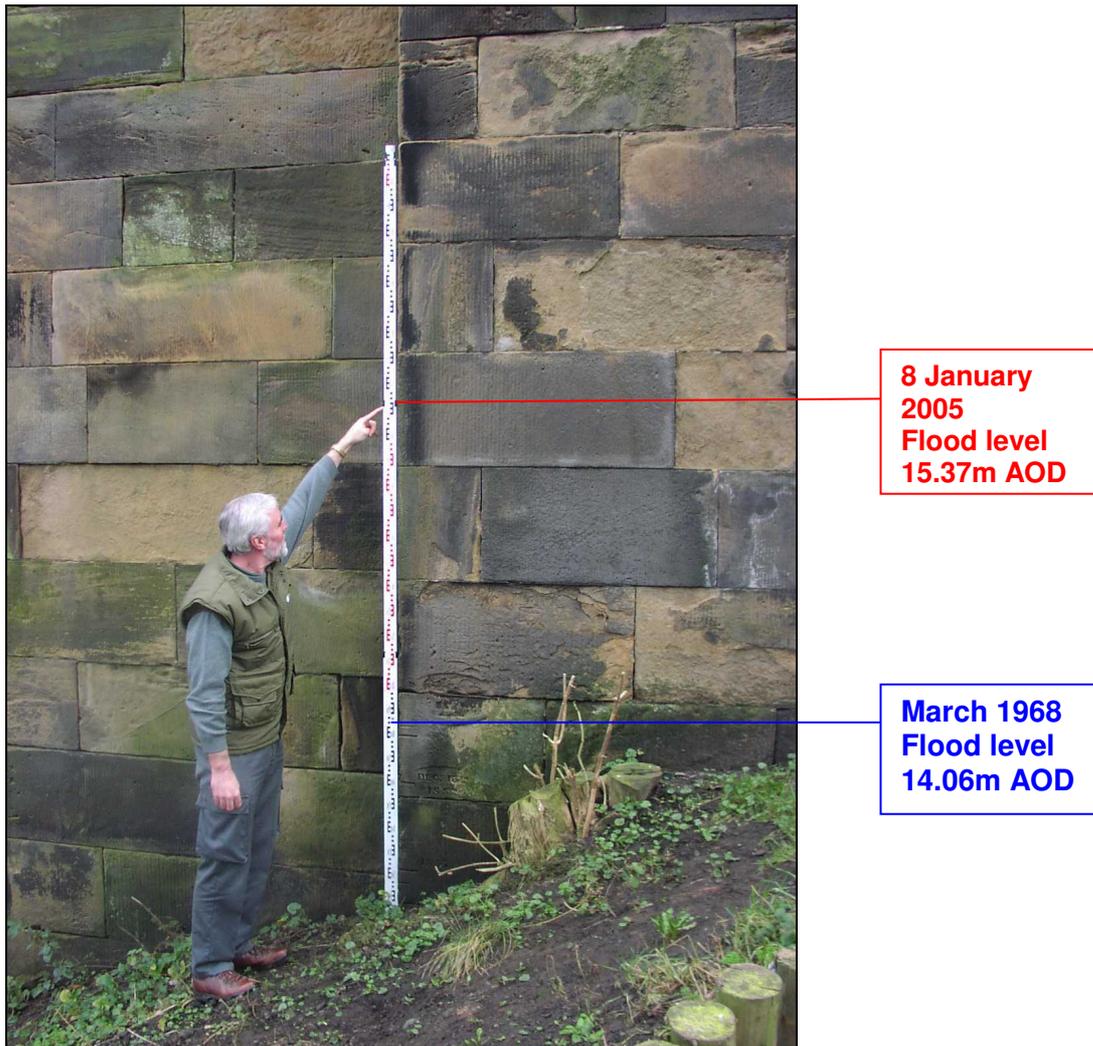
Photograph 4-1: Flood Levels on Eden Bridge

From the flood records for Eden Bridge, which include the flood marks and a staff gauge maintained by the City Council between about 1850 and the 1930s, the 2005 flood appears to be the highest recorded. It was more than 1m higher than the notable floods of 1771, 1822, 1856, 1925 and 1968. This gives some credence to the estimate of 175 to 200 year (0.57% - 0.5%) for its return period and may even indicate that it is an underestimate.

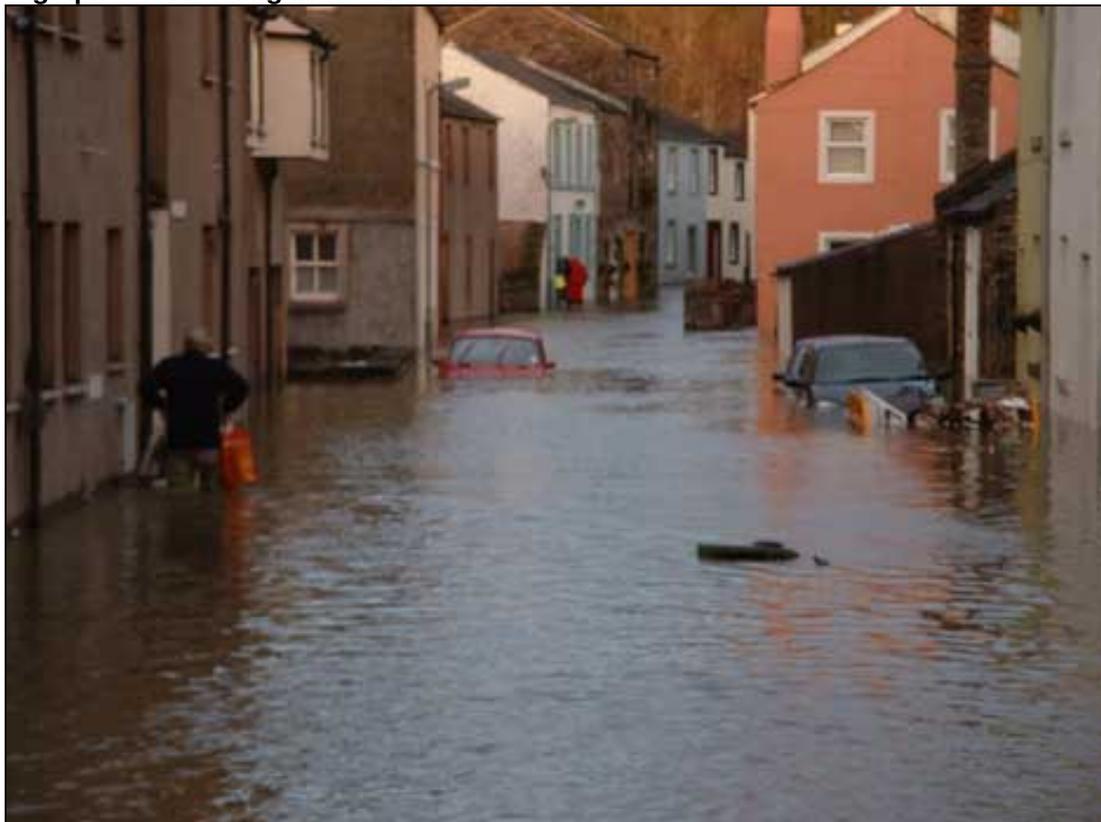
Photograph 6-1: Flooding in Waterloo Street

Some 34 properties suffered internal flooding and the maximum depth of water in the road was approximately 0.9m.

Flooding initially occurred to a property at the confluence, by the footbridge in Waterloo Street. This was at 0000hrs on 7 January and was due to a faulty stop log, which is owned by a resident.

The left bank at Waterloo footbridge overtopped during the event. Water was seen coming through the gap at the footbridge, where the riverside steps have wooden stoplogs. Water flowed from along Waterloo Street in a westerly direction and spread southwards along High Sands Lane to flood Main Street.

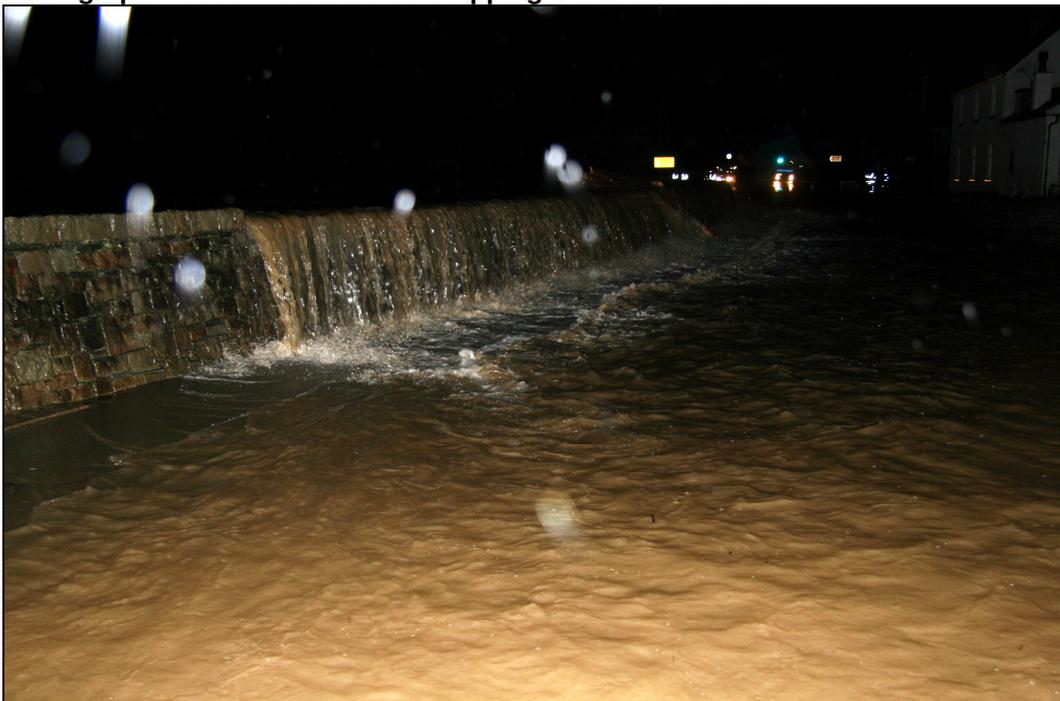
Photograph 6-5: Flood waters overtopping a wall in Keswick

In Keswick, the Greta and its tributaries rose significantly between the morning of 7 January and the early hours of 8 January. The defences on High Hill were overtopped by 150mm and the embankment in Crosthwaite Road by 0.5m. Water that overtopped the Crosthwaite Road embankment joined Crosthwaite Beck. The exterior wall at the Keswick Youth Centre, which acts as a flood defence, also leaked badly.

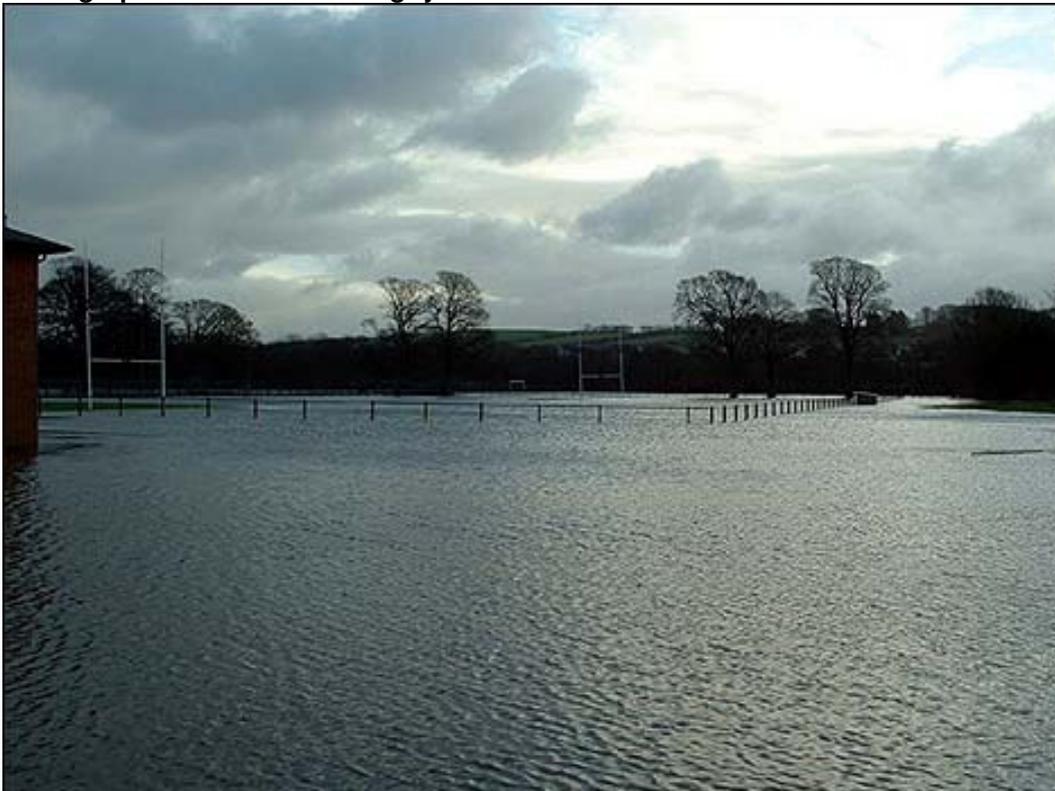
Photograph 6-7: Netherhall Rugby Club flooded

A member of the public informed us the Rugby Club flooded, which has since been confirmed. Wrack marks show that water covered most of the car park and so it appears likely that the club did flood. Practically all of the sports fields were under water during the event and there were wrack marks along the fence at Netherhall School.

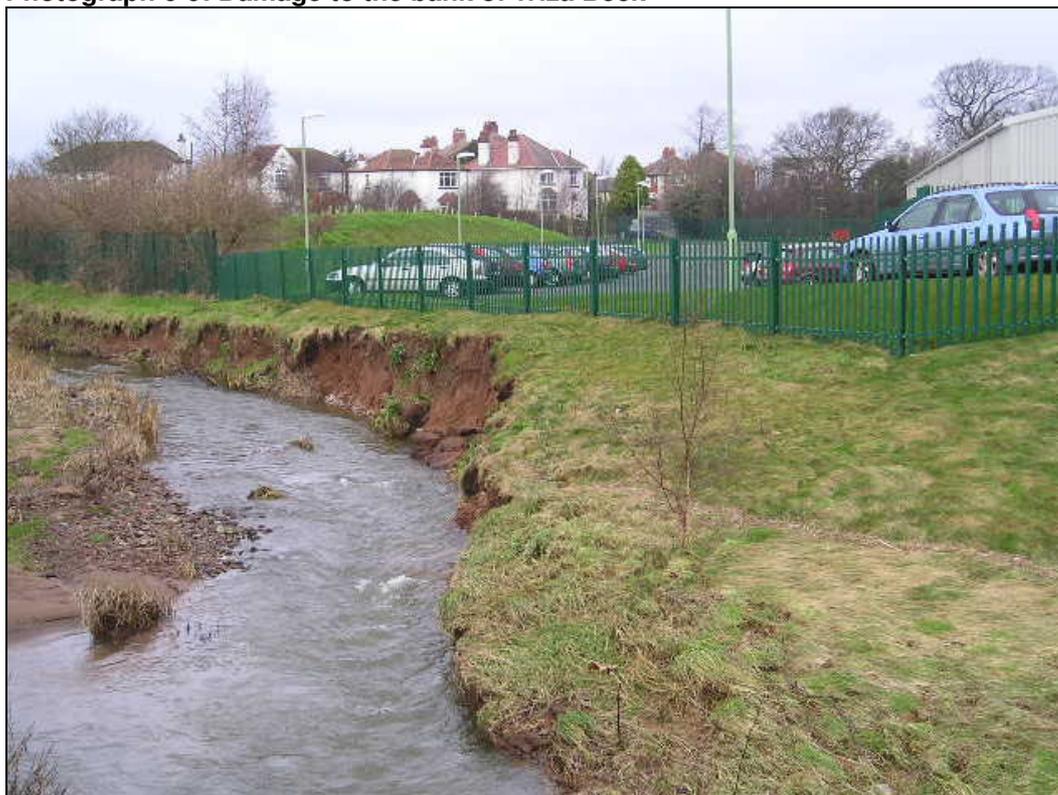
Photograph 6-9: Damage to the bank of Wiza Beck

The river first came out of the channel at a recently constructed bridge at the entrance to a factory; flows ran down the highway and onto Station Road. Subsequently, the river bank along Station Road was overtopped by up to 75mm along its 125m length. Water flowed through the industrial estate and back into both Wiza Beck and Speet Gill. The depth of flooding was comparatively shallow at some 300mm. The highway bridge, which is on a 90 degree bend with limited capacity, is the main problem in this area. Ten properties, three houses and a residential caravan site flooded.

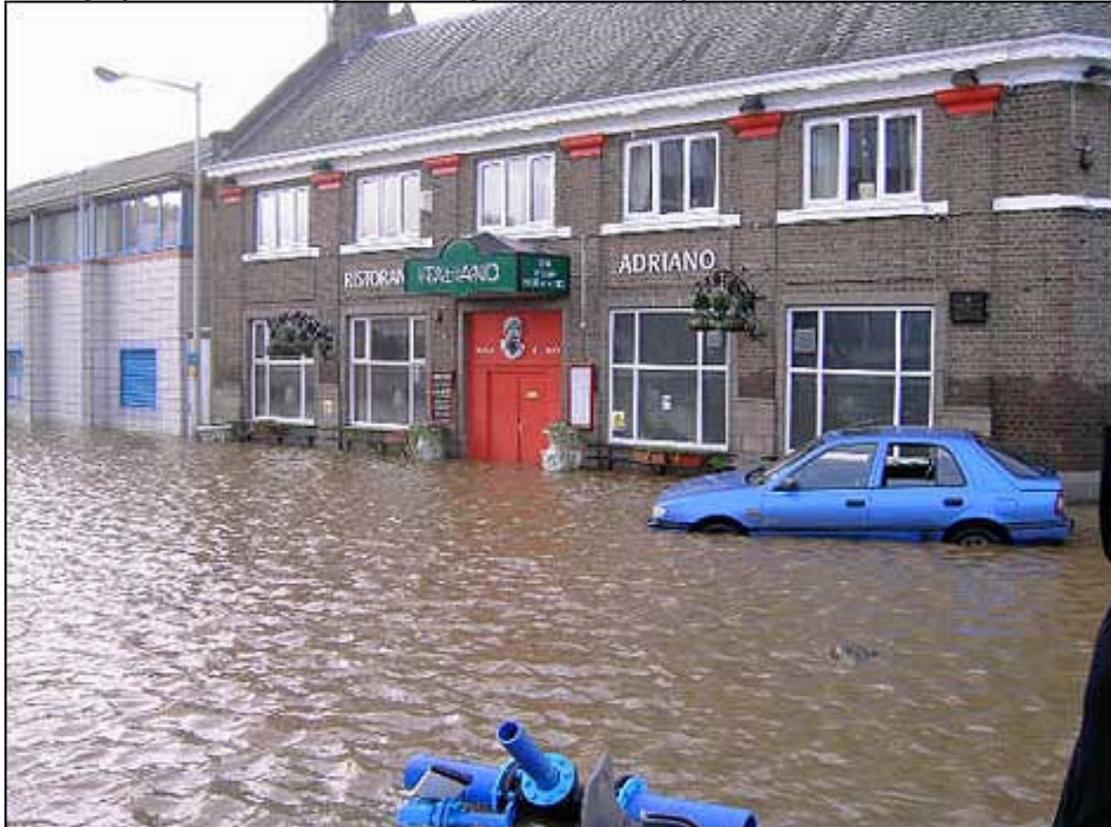
Photograph 6-12: Flooding at Rickergate on 8 January 2005

Downstream of Victoria Viaduct to Caldew Bridge, the defences on the right bank were overtopped and commercial and residential properties flooded. There is a flow route from this area to the Eden and flows from both rivers eventually merged. Evidence from CCTV suggests that the initial flooding to the right bank was from surcharging of the surface water system. The Shadongate area is low lying and it received flows from the Caldew via the Little Caldew; it flooded to a depth of some 1.8m. The defences to the left bank were overtopped to a very limited extent, directly downstream of Victoria Viaduct; no properties flooded and the affected area was very small. This flooding occurred between 0230hrs to 0430hrs.

A second phase of flooding occurred to the lower areas of the Caldew at 1100hrs and is likely to have been caused by backing up from the Eden.

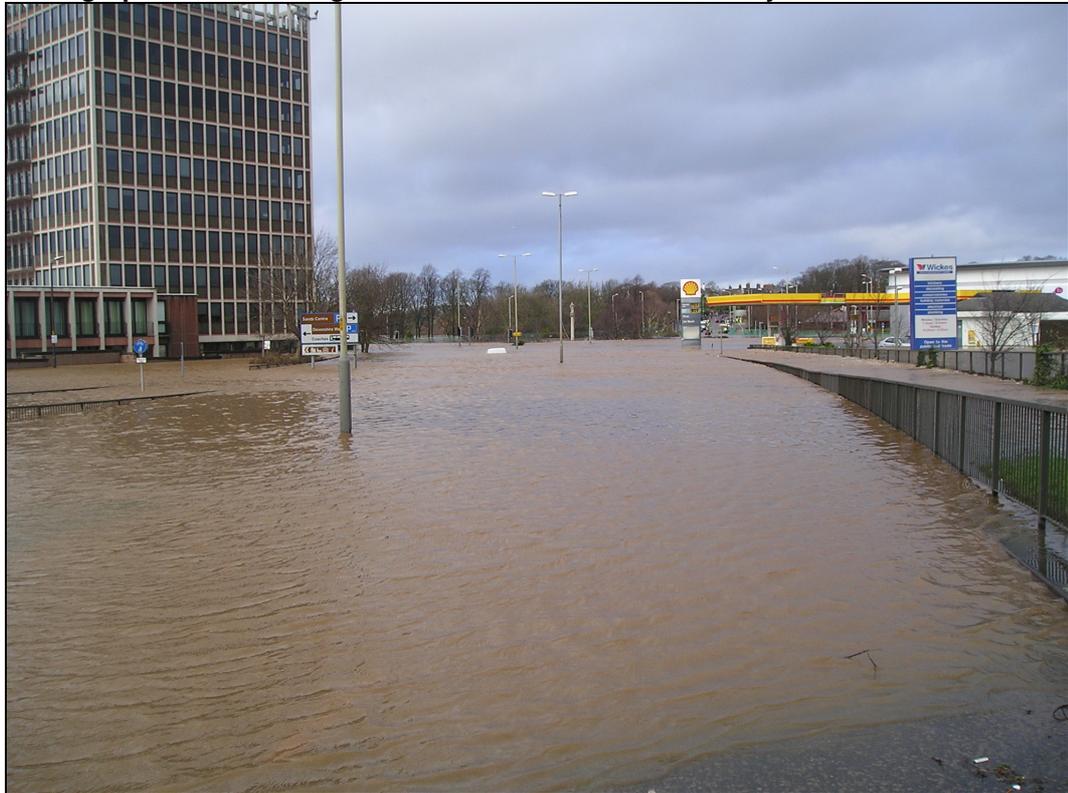
Photograph 6-13: Flooding at Hardwicke Castle on 8 January 2005

The area around the Civic Centre and Hardwick Circus was just included in the Flood Zones as a result of recent modelling. The AVM take-up was very low. Of the 66 properties which flooded, only three took up the offer.

Anecdotal evidence suggests that the initial flooding was caused by surcharge of the sewers, after the power failure from 0600hrs to 0830hrs. The principal cause was flows from the Eden and water bypassed Eden Bridge and flooded the underpasses into the city centre between 0930hrs and 1100hrs. Flows also overtopped the embankments downstream of Eden Bridge at the same time. The depth of flooding was 2m in places.

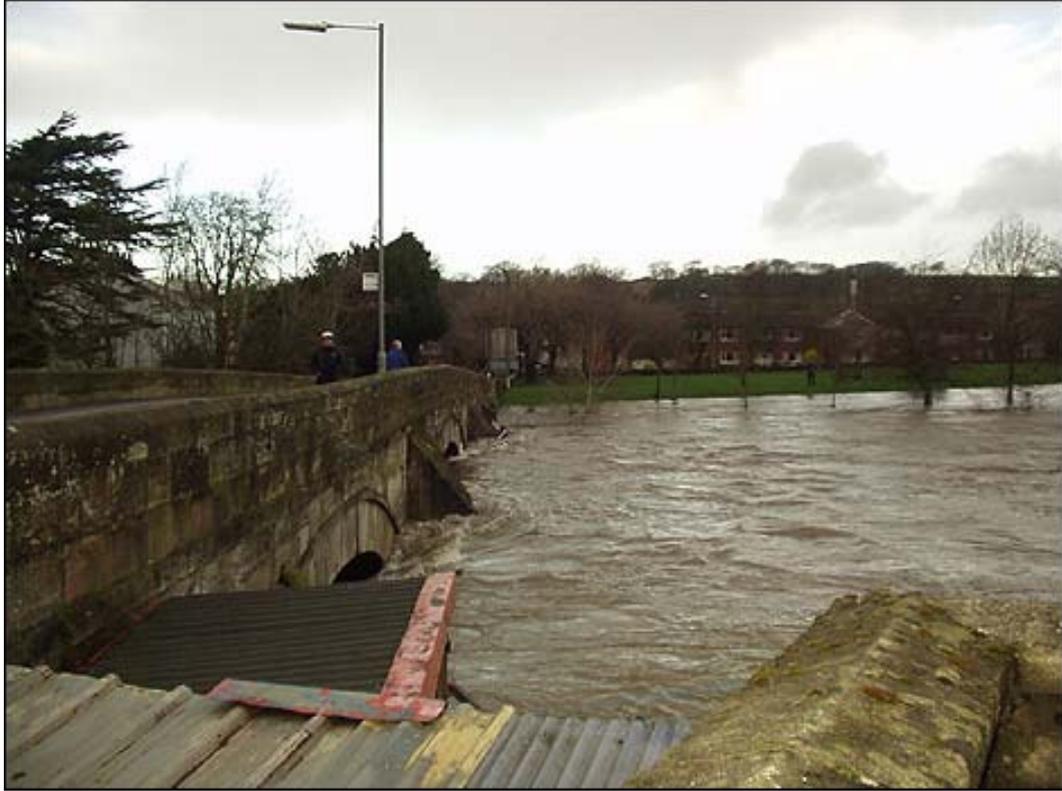
Photograph 6-15: Bridge in Cockermouth beginning to restrict flow

According to nearby residents, the main development site on the opposite side of the river began to flood at 2230hrs on 7 January. The onset of property flooding was at 0300hrs of 8 January. Flows came out of the right bank as a result of a build up of debris on the handrails of a low bridge. Water also flowed overland from the bridge leading to Robin House. Runoff from the land and lanes above the development flooded properties in the north west corner of the site. Flooding depths were substantial and up to 1m in places.

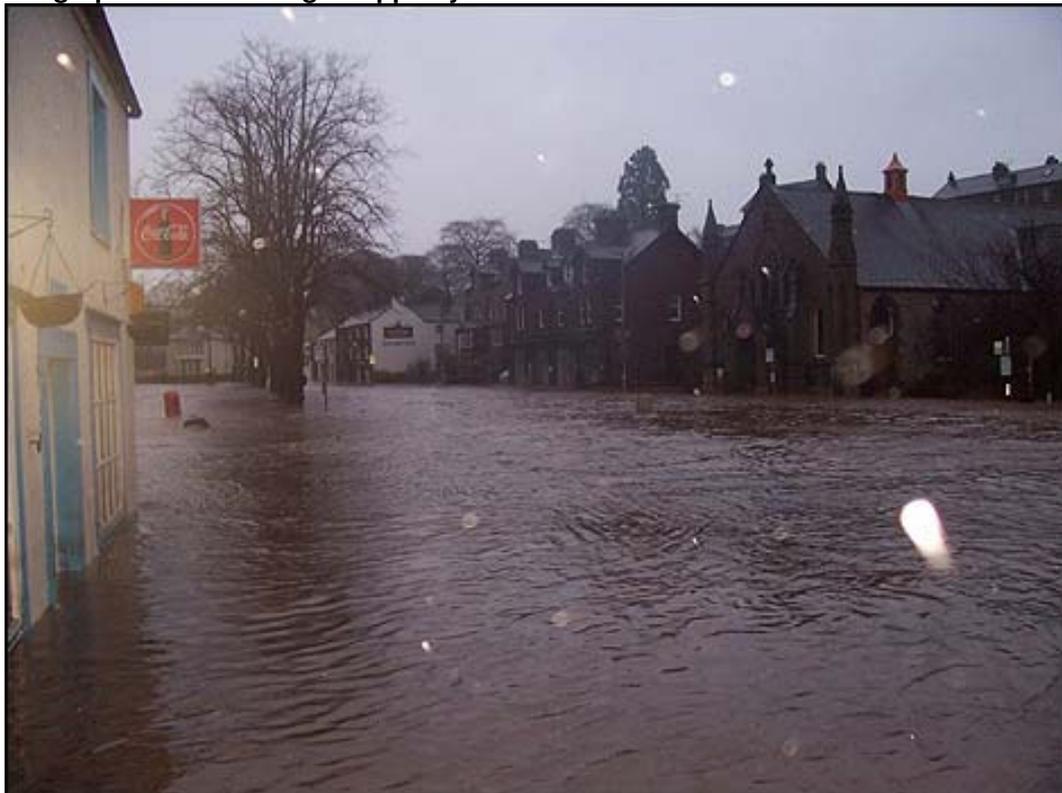
Photograph 6-17: Flooding in Appleby

The River Eden started to flow out of bank between 1700hrs and 1800hrs, by which time the police and fire and rescue service were in position on Bridge Street, opposite The Sands. They undertook traffic control and helped with the sandbags.

The river continued to rise. Excess flows left the main channel in the bowling green area, passed along The Sands and returned to the channel downstream of the bridge. Properties along The Sands started to flood at 2100hrs. Within a couple of hours, The Sands was impassable and was under a depth of water of 1.2m. Water levels reached a peak at 0415hrs on 8 January.

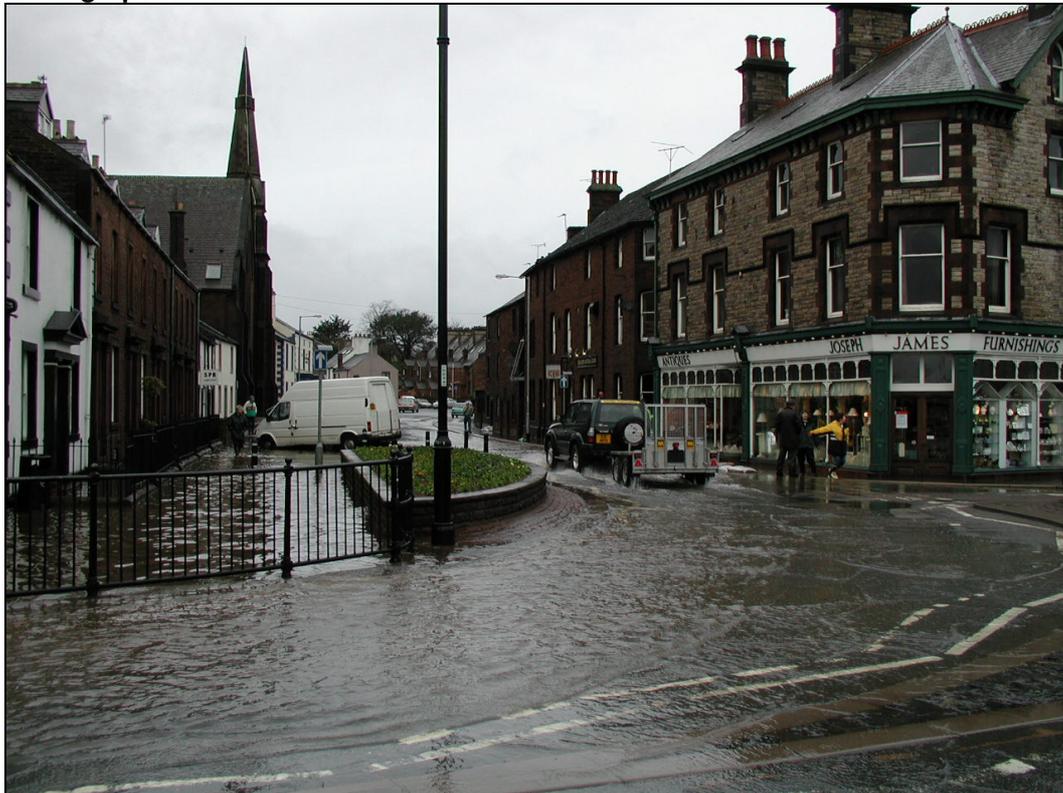
Photograph 6-22: Penrith town centre

The watercourses of Thacka Beck, Myers Beck and Dog Beck have a history of flooding in Penrith. Much of Thacka Beck is culverted through the town. There are no flood defences.

On this occasion, flooding only appears to have been from Thacka Beck. The areas affected were the rural floodplain and urban channel through the town centre.

The town centre was affected at four locations and a number of residential and commercial properties were flooded. The volume of water flowing through the culverts was sufficient to raise manhole covers and lift the tarmac.

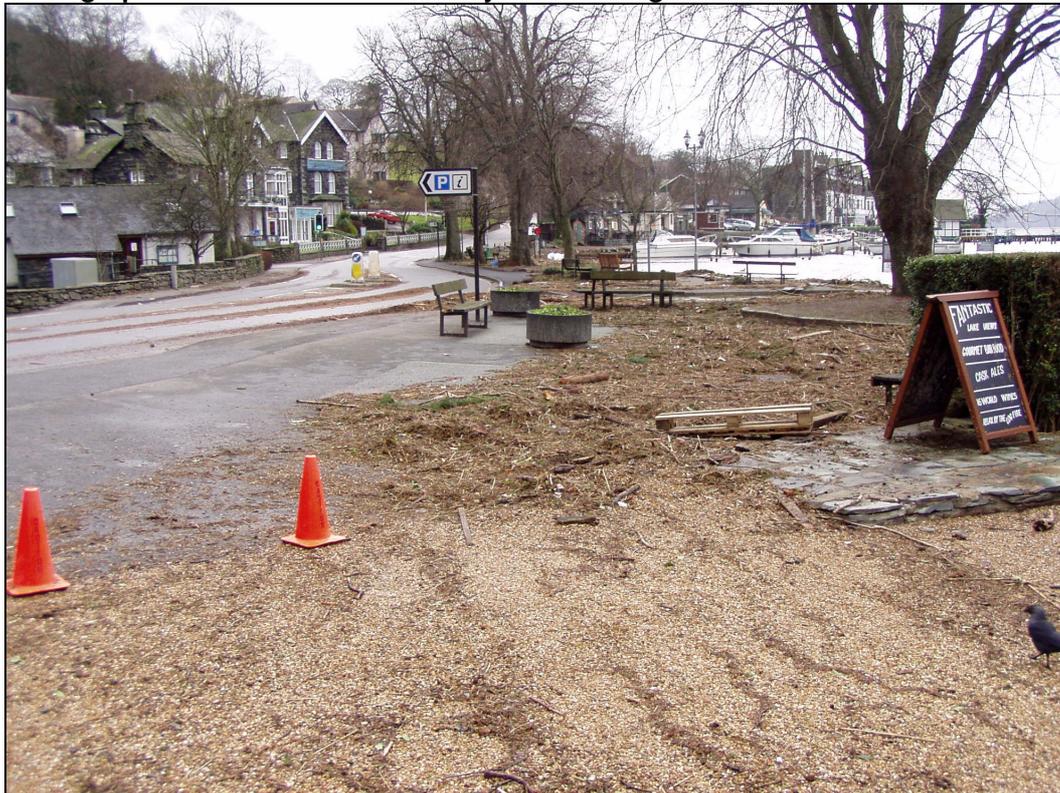
Photograph 6-23: Debris left behind by the receding flood waters in Waterhead

Large amounts of debris from the lake were deposited by the prevailing wind in Borrans Road at Waterhead. Sandbags prevented water entering The Waterside Inn, although the beer garden was inundated and a substantial amount of debris remained when the water receded. The low lying car park at Waterhead was flooded.

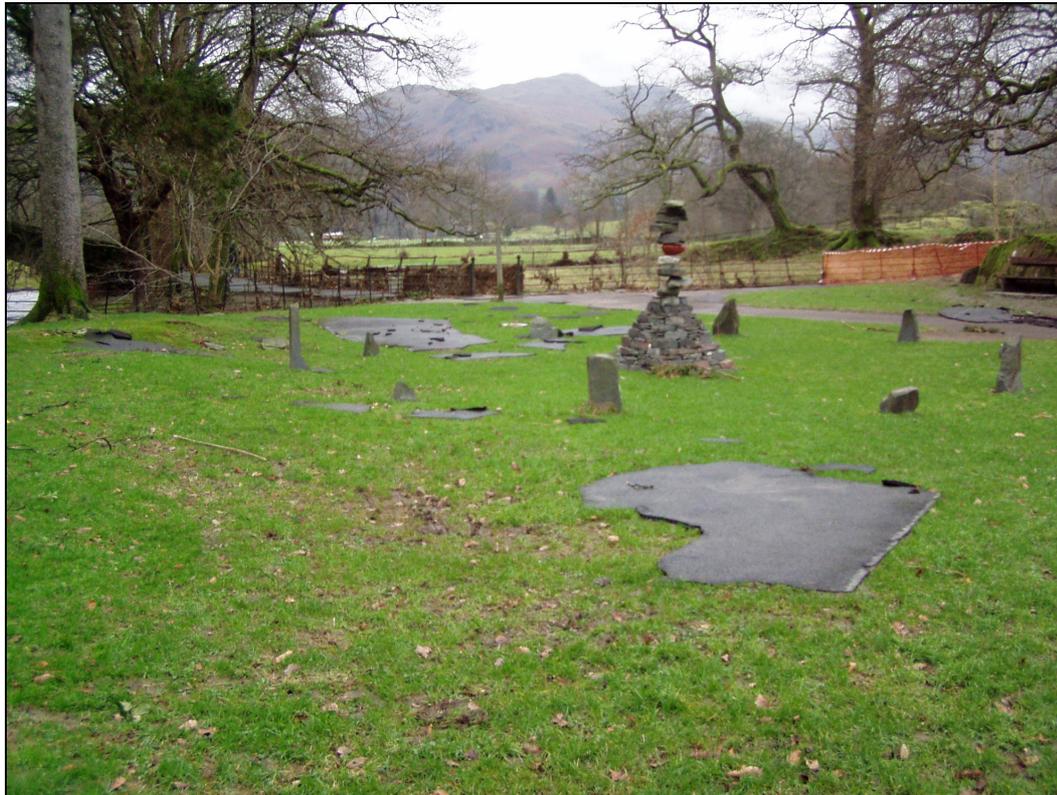
Photograph 6-24: Slabs of tarmac in Rothay Park had been carried away by the flood waters

On the left bank, most of Rothay Park was inundated. Large slabs of tarmac from the footpath in the vicinity of Miller Bridge were lifted and carried across the grass. The defence level downstream of the Miller Bridge House Gauging Station is high and the river was contained. There was wrack less than 0.5m from the top of the bank. The water in Rothay Park flowed over the wall on the north side of the children's playground. It flowed through the playground, washed out much of the ground and demolished a fence. It flowed over the football pitch, through the sewage treatment works and flooded some of the properties around the business park. These include

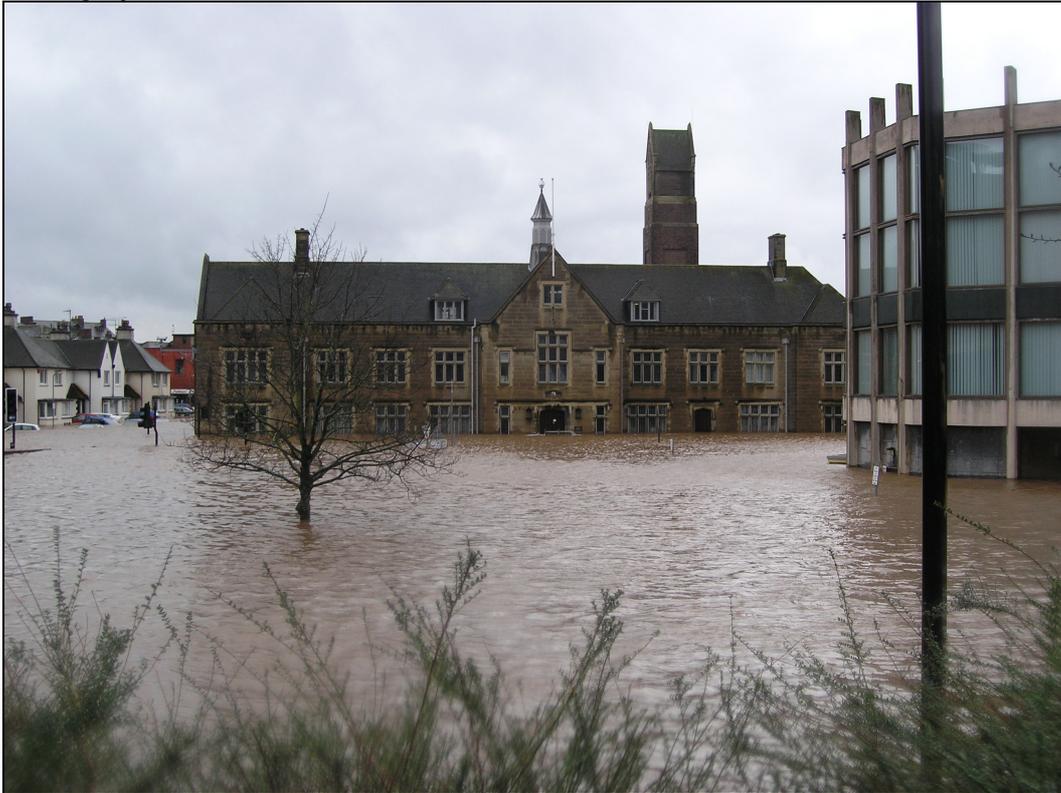
Photograph 6-26: The Police Station in Carlisle flooded

The police stations in Carlisle, Penrith and Appleby suffered severe flooding. The former was flooded to a depth of 2.5m and most of its vehicles were damaged. Over 18 months later the police in Carlisle are still in a temporary police station in the city. A permanent new site is being sought rather than returning to Rickergate Station. The closure of the Carlisle Police Station is the only closure of a major police station during peace time.

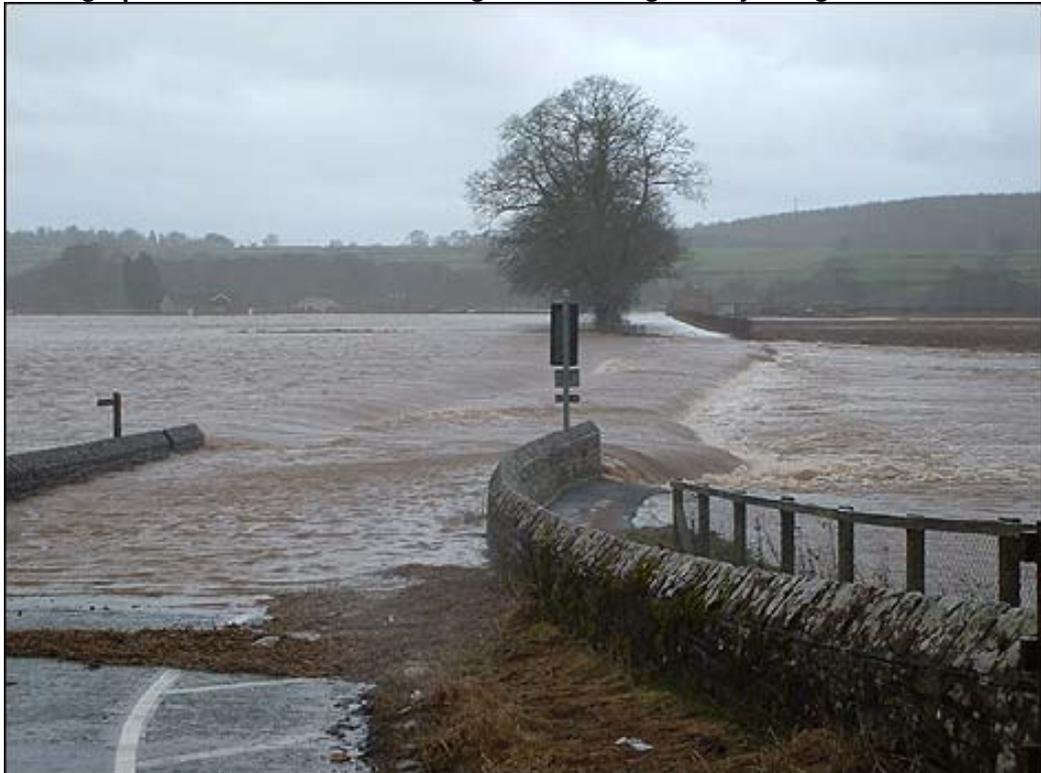
Photograph 6-34: River Eden flooding A686 at Langwathby Bridge

The A686 at Langwathby Bridge was significantly damaged by the flood waters and was closed for several days.

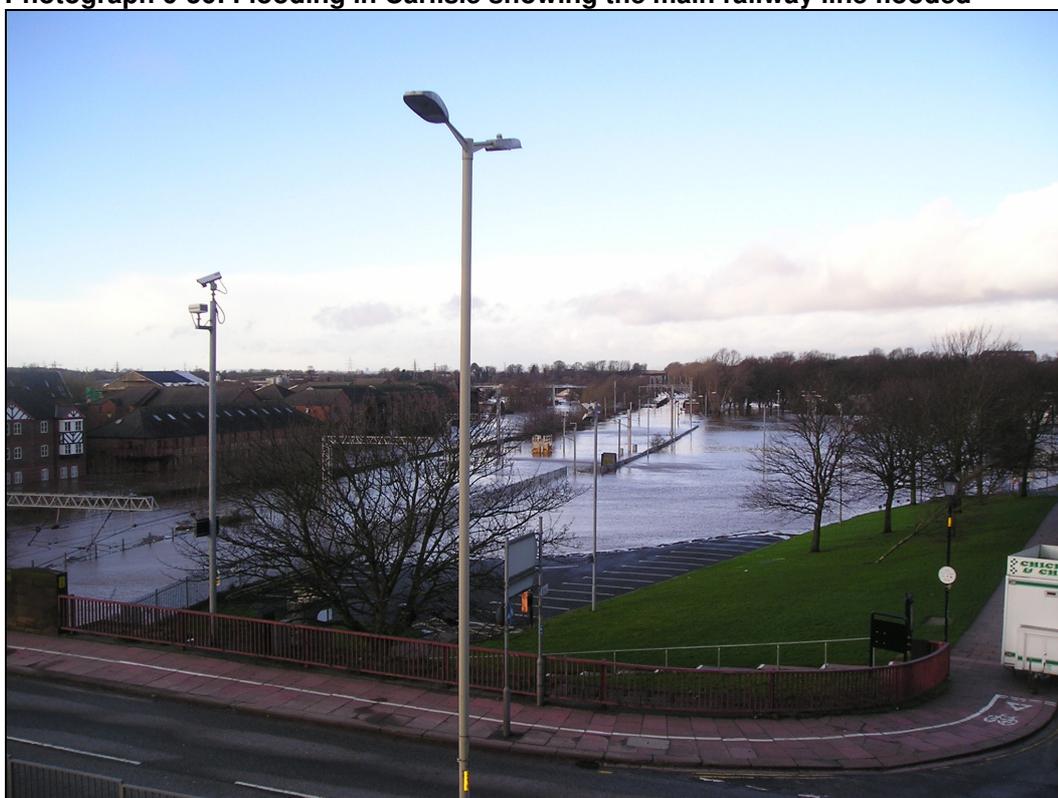
Photograph 6-36: Flooding in Carlisle showing the main railway line flooded

Train services in the county suffered significant disruption due to the flooding and high winds. The West Coast Main Line (WCML) was closed at Carlisle due to damage to the line from flooding; it was reopened more than a week later. Virgin Trains had to put on a bus service between Carlisle and Lockerbie. Virgin Trains estimate the costs of the closure were in the region of £7.5m.

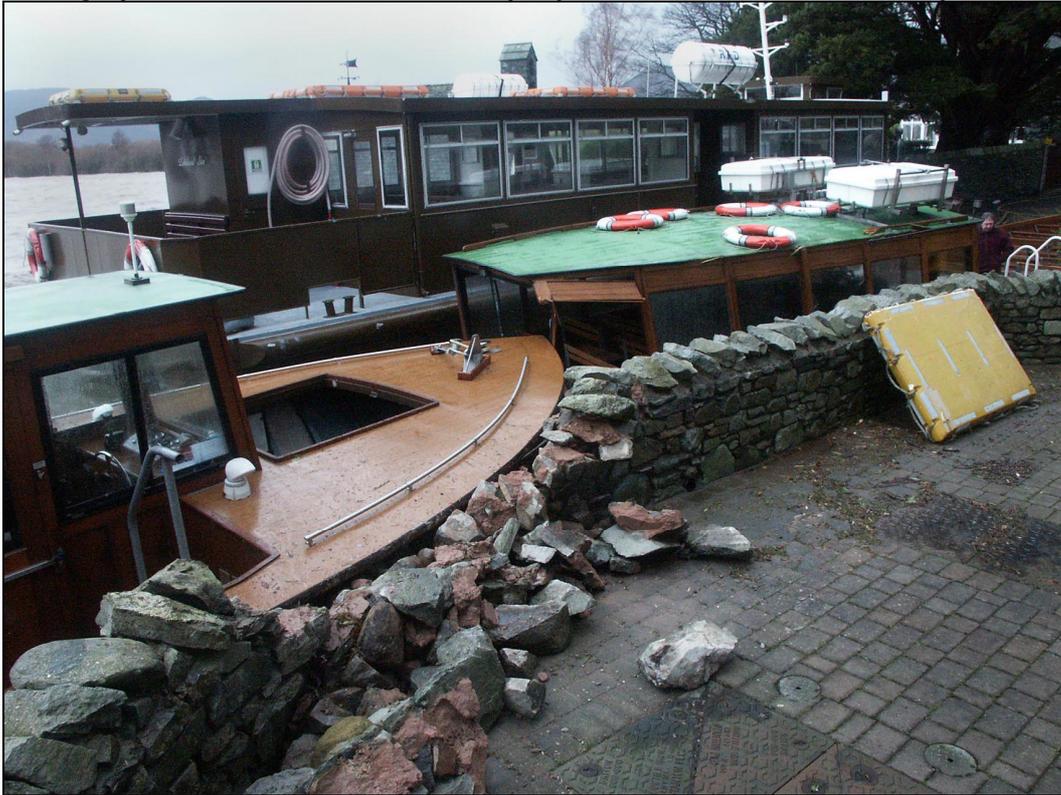
Photograph 6-37: Keswick Launch Company boats that were washed away

74 boats were washed away, including three launches belonging to the Keswick Launch Company.
